DEPARTMENT OF TRANSPORTATION**DIVISION OF ENGINEERING SERVICES**

Contract #: 04-0120F4Cty: SF/ALA Rte: 80 PM: 13.2/13.9File #: 69.28**WELDING INSPECTION REPORT****Resident Engineer:**Pursell, Gary**Address:** 333 Burma Road**City:** Oakland, CA 94607**Report No:** WIR-002876**Date Inspected:** 09-Jun-2008**Project Name:** SAS Superstructure**OSM Arrival Time:** 630**Prime Contractor:** American Bridge/Fluor Enterprises, a JV**OSM Departure Time:** 1530**Contractor:** Zhenhua Port Machinery Company, Ltd (ZPMC), Changxing Island **Location:** Shanghai, China**CWI Name:** Hu Wei Qing and Lvliqing**CWI Present:** Yes No**Inspected CWI report:** Yes No N/A**Rod Oven in Use:** Yes No N/A**Electrode to specification:** Yes No N/A**Weld Procedures Followed:** Yes No N/A**Qualified Welders:** Yes No N/A**Verified Joint Fit-up:** Yes No N/A**Approved Drawings:** Yes No N/A**Approved WPS:** Yes No N/A**Delayed / Cancelled:** Yes No N/A**Bridge No:** 34-0006**Component:** OBG and SAS Tower Fabrication**Summary of Items Observed:**

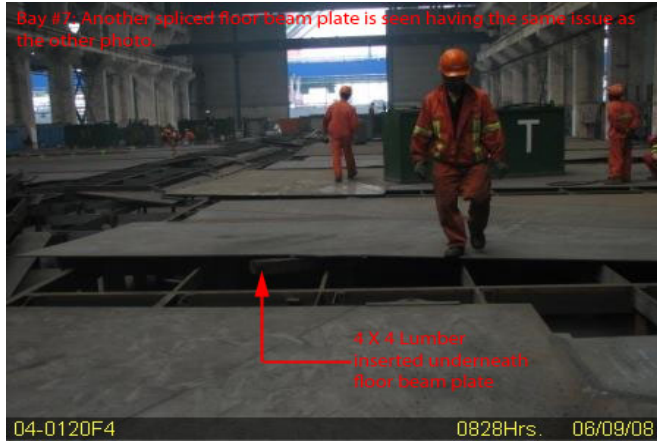
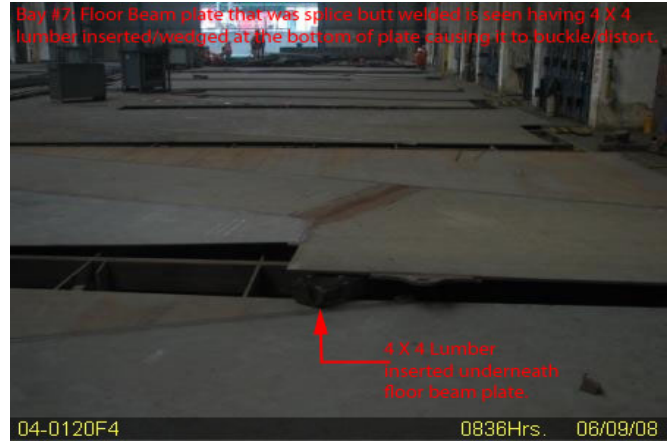
This QA observed two incidents wherein spliced butt floor beam plates were inserted/wedged with 4" X 4" lumber at the edge of these plates which could make it buckle or distort and lost its flatness. This QA called the attention of ZPMC CWI HU Wei Qing and one ABF QA inspector regarding this concern. Both Inspectors responded by saying they will ask ZPMC personnel to correct such concern. See photo below.
